## MARINE SURVEY REPORT

**Report Number :** 2009P/1501  
**Date of Inspection :** May 20, 2009  
**Commissioned by :** XXXXXX XXXXXXXX for insurance purposes.  
**Address :** XXXXXXXXXX  
XXXXXXXXXX  
XXXXXXX  
**e-mail :** XXXXXX@XXX.ca  
**Phone :** XXXXXXXXX

**Make of Vessel :** Doral, Cavalier  
**Name of Vessel :** XXXXXXXX  
**Model year :** 1989  
**Date of mfg. :** February 1989  
**License Number :** XXXXXXXX  
**HIN/MIC :** ZDBXXXXXB989

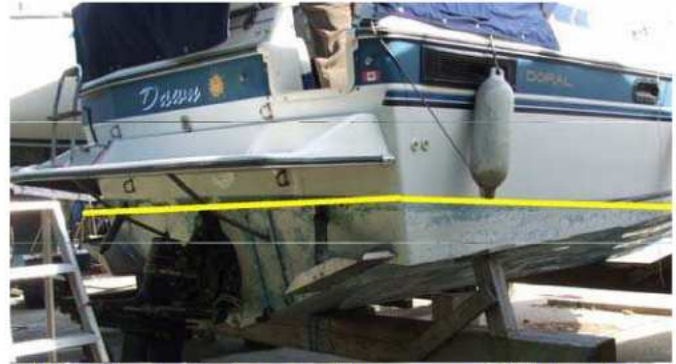
*Yellow line indicates scum line approx. 8" higher than normal at the transom center.*

**Bottom :** The hard chined bottom is virtually bare of antifouling paint and checks sound with moisture levels low to slightly elevated forward of amidships and high in the aft quarter with slightly dull soundings. See comment (2)

2. Coat bottom with antifouling paint.
5. Monitor swim platform and repair as required.
9. The Canada Shipping Act prohibits the discharge of petroleum products. The addition of drip pans under the engines will help prevent such discharges through the bilge pumps.
11. Canadian Coast Guard "Collision Regulations" require a vessel of less than 20 meters or constructed of non-metallic materials to be equipped with a passive radar reflector if the vessel will operate in an area where radar navigation is in use, after sundown or in unfavourable environmental conditions.
22. TP1332E requires the following labels or placards be fitted in visible locations. *Safety Notice Compliance, Fuel Tank, Blower Instruction Placard , Oil Disposal and Garbage Disposal*

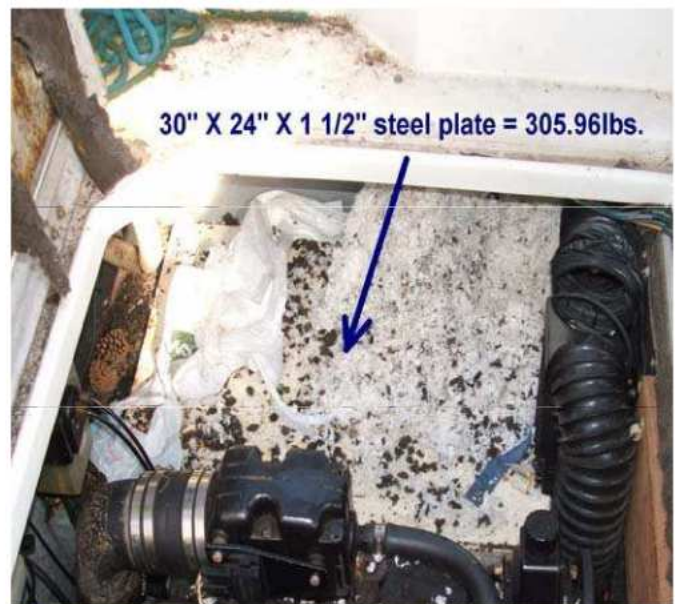
**Frames / Bulkheads :** The port bulkhead and deck in the engine compartment under the steel plate is rotten. The opposite bulkhead/deck checks slightly dull with high moisture levels. See comment (1).

*309lb. steel plate in engine compartment painted white.*

1. This bow high attitude in part caused by the approximately 309lbs. of ballast and a water logged transom and aft quarter of the bottom and will make piloting difficult and likely erratic. Remove ballast otherwise the vessel is not suitable for more than port risk.

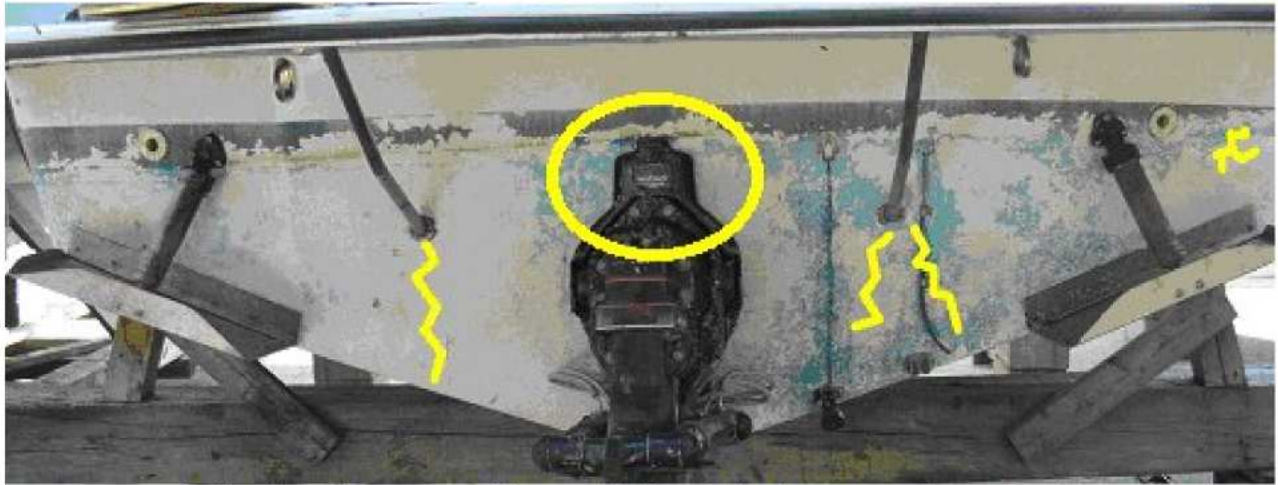
**Transom :** The transom shows high moisture levels with areas of core separation as revealed by percussive soundings. The transom is compressed around the top end of the transom assembly and there are several areas of fracture as shown by the yellow line in the photo below. See comment (3).

*Yellow lines show areas of fracture. Yellow circle shows area of compression  
Note the scum line that shows the transom assembly will be fully submerged in water.*

3. Repair transom. Until repaired the vessel is not suited for more than port risk.
8. NFPA 302 requires that insulation in an engine or fuel compartment have a flame spread index of 75 or less and be marked as such. This insulation must be removed from the compartment.

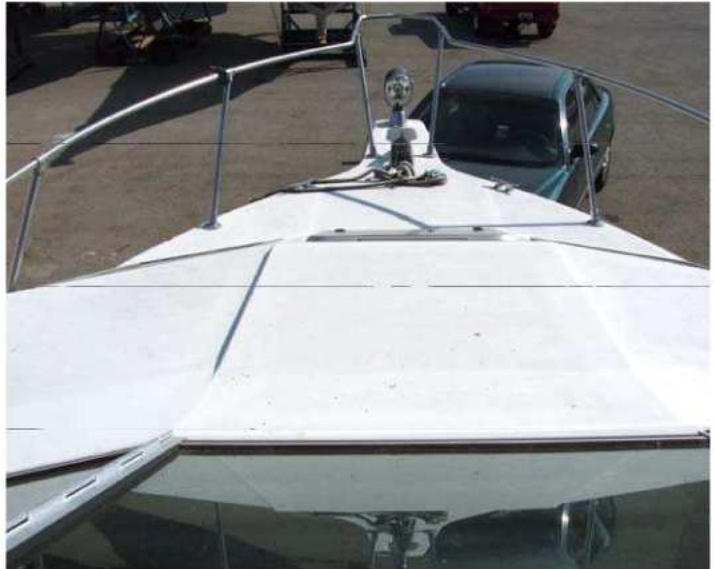
Stainless steel bow pulpit and side rails are secure as are bow, midship and stern mooring cleats. An integral bow platform is fitted with a single anchor roller and is followed by a secure rode pipe. An escape hatch and two deadlights forward on the trunk are secure as is the aluminum framed windshield fitted with safety glass as required. Port/starboard acrylic deadlights with inset ports are secure but the port deadlight is fractured and leaks at fore and aft ends as shown by water stains inside. See comment (4).

4. Replace cracked port side deadlight.
6. Remove peanut shells from around DC fuse block and inspect all DC wiring.
7. Repair skeg on lower unit. Raise unit and inspect bellows.

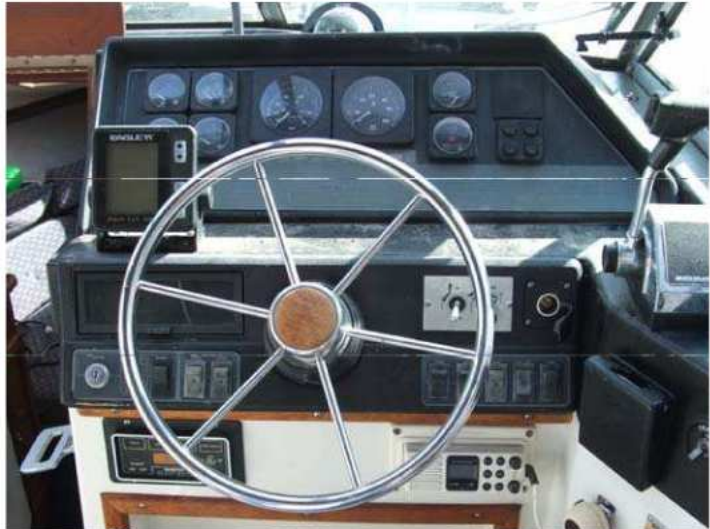
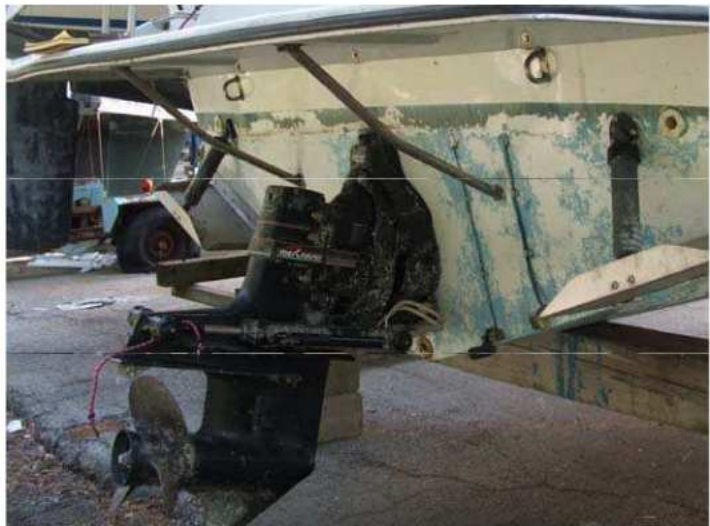
**Drive system :** Mercruiser Inboard /outboard drive assembly is secure and shows minimal bearing play. Drive could not be lowered to fully inspect bellows but they did seem stiff. Skeg is broken.  
See comment (7).

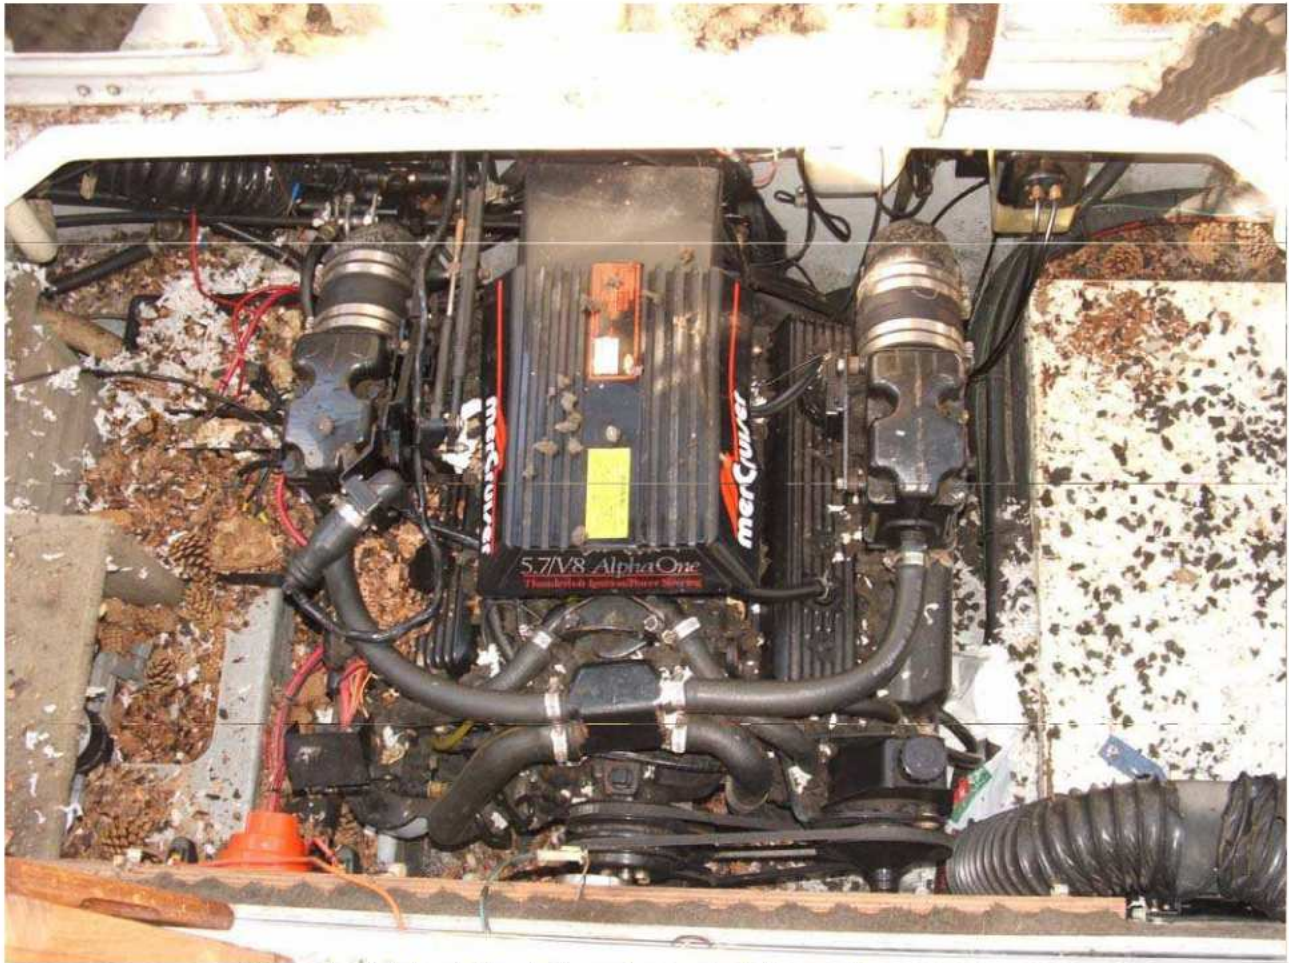
The engine compartment contained several cubic feet of rodent nesting material which the surveyor was reluctant to dig through for a complete inspection. Insulation on the hatches does not appear to be fire rated. See comment (8).

*Several cubic feet of rodent nesting material in engine compartment.*

17. There may be a 12VDC bilge pump under the rodent debris in the engine compartment, if not, one should be fitted.
18. Remove mould from toilet.
19. ABYC "Carbon Monoxide Detection Systems" Standard A-24, NFPA 302, USCG and CCG strongly recommend the installation of carbon monoxide detectors.

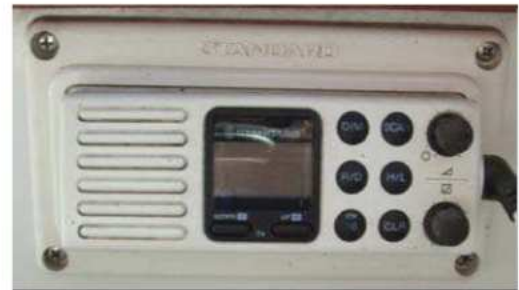
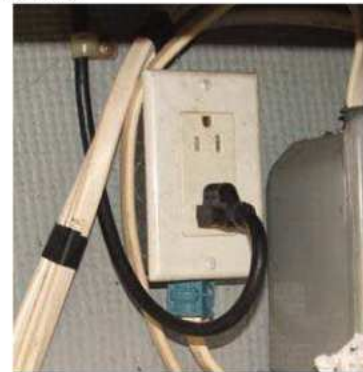
**AC Ignition Protection :** An AC outlet in the engine compartment is inherently not ignition protected.  
See comment (12).

*AC outlet in engine compartment*

12. ABYC "AC and DC Electrical Systems On Boats" Standard E-11 recommends and Transport Canada TP1332E requires that all electrical fixtures and systems in a compartment containing gasoline must be ignition protected.

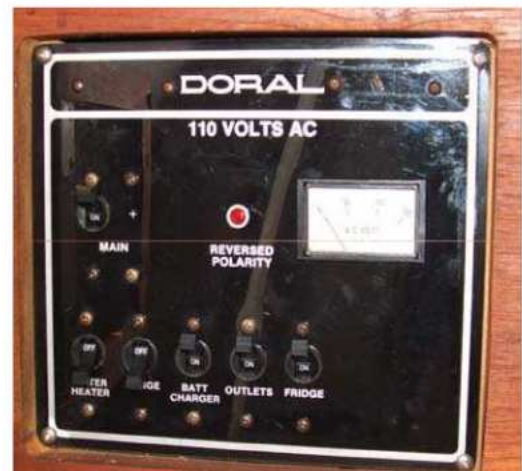
*AC panel*

**AC panel :** Original equipment type panel with single pole main breaker, polarity indicator, volt meter and accessory breakers in good visual order.
