## MARINE SURVEY REPORT

**Report Number :** 2009P/1501  
**Date of Inspection :** May 20, 2009  
**Commissioned by :** XXXXXX XXXXXXXX for insurance purposes.  
**Address :** XXXXXXXXXX  
XXXXXXXXXX  
XXXXXXX  
**e-mail :** XXXXXX@XXX.ca  
**Phone :** XXXXXXXXX

**Make of Vessel :** Doral, Cavalier  
**Name of Vessel :** XXXXXXXX  
**Model year :** 1989  
**Date of mfg. :** February 1989  
**License Number :** XXXXXXXX  
**HIN/MIC :** ZDBXXXXXB989

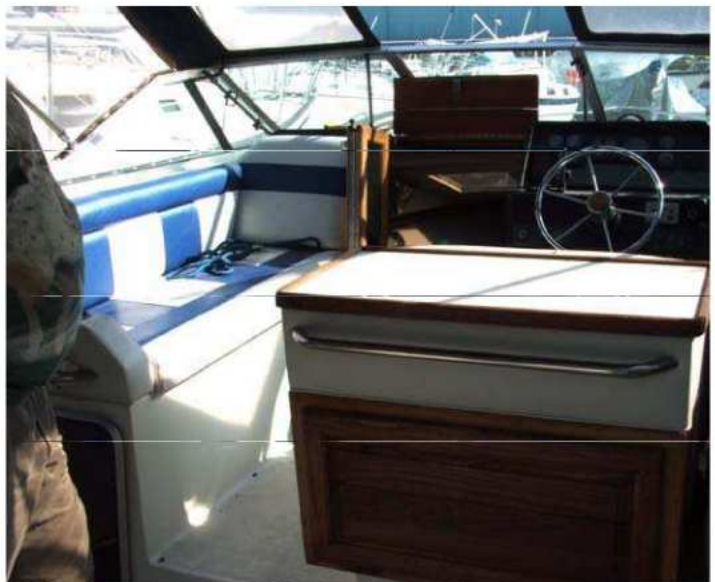
The cockpit is accessed via the starboard side transom step-thru and a large engine compartment hatch with two man doors is sound as is the aft folding passenger bench and escape hatch from the mid-cabin berth. Forward to port is a passenger bench with the pilot bench opposite. A wood and acrylic companionway door is sound and secure. A stainless steel frame supports a full canvas enclosure in good condition.

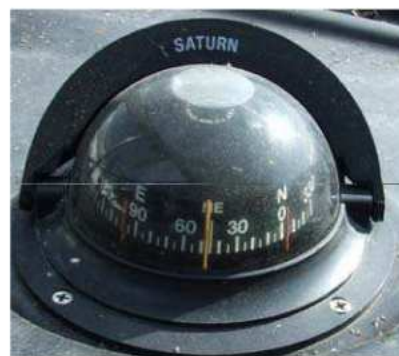
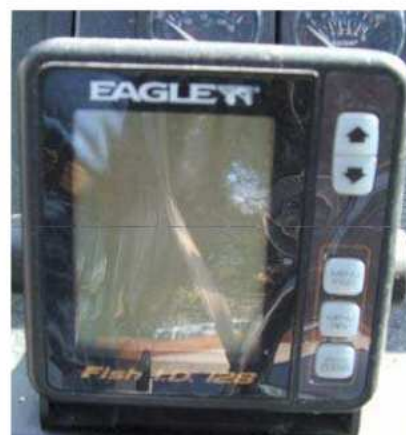
<b>Navigation lights:</b>	All in place as required by Collision Regulations
<b>Compass :</b>	Saturn 4" fluid damped type is clear and responsive to magnetic influence.
<b>Radar :</b>	n/a
<b>Radar reflector :</b>	None sighted. See comment (11).
<b>Chart plotter :</b>	n/a
<b>GPS :</b>	n/a
<b>Loran :</b>	n/a
<b>Depth sounder :</b>	Eagle Fish I.D. 128
<b>Sound signal :</b>	12VDC horn.
<b>Knot log :</b>	Speed only
<b>Marine radios :</b>	Horizon Galaxy VHF
